Ref. No.: MOZ08020002

Assessment of the impact of the rehabilitation works in Maputo primary schools

Prepared by: Eugénio Munguambe

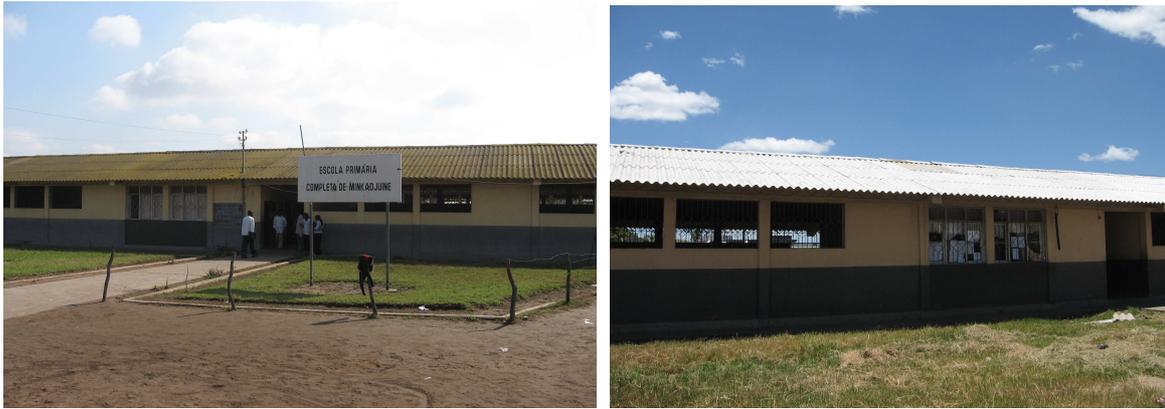
Picture 1 e 2. EPC Minkadjuine before and after the rehabilitation

The Minkadjuine Complete Primary School had a toilet in dreadful conditions. The roof, apart from allowing the entry of rainwater and Sun rays, claimed for cleaning. The walls and floor of the classrooms and the school Board also claimed for rehabilitation.⁷

This school benefited of rehabilitation of the student's toilets and cleaning, and replacement of the ceiling sheets. Apart from this intervention, the school received 220 student desks and 10 desks with chairs.

The EPC Minkadjuine is a very clear example in this sector of intervention. The problem with the rain, which caused concern to parents, teachers, tutelary institutions, as well as to the students themselves was solved, thus, allowing the normal course of the lessons, as we can see from the pictures below.

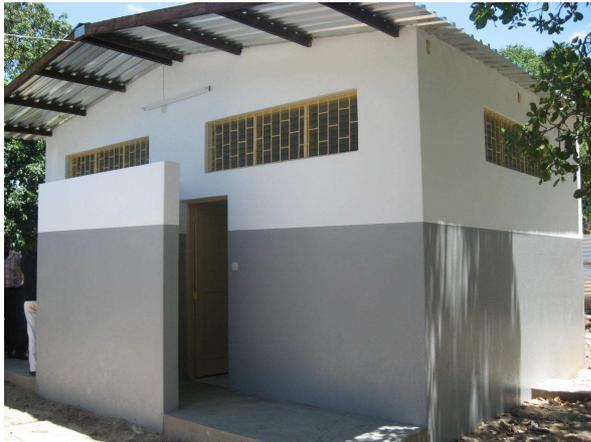
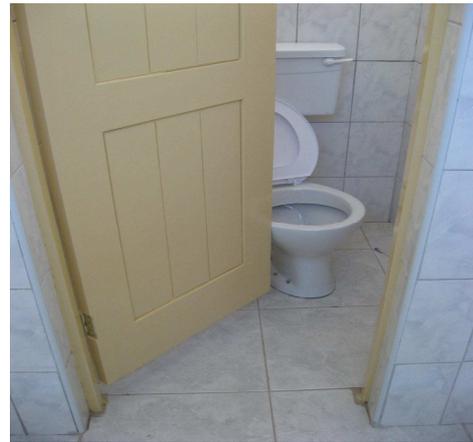
Pictures 3 and 4 toilets of the Guaxene EPC after the rehabilitation

The problems of the Guaxene EPC were not only the toilets. According to Augusto José Nhaca, headmaster of the school, most, if not almost all students, had lessons while sitting on the floor due to the lack of desks. For an universe of 11 classes, each of them, according to the headmaster, with an average 50/55 students, the school only has a total of 38 desks.⁸ There were also problems with the fencing, as people use the school yard as a passage. The painting and the floor are also degraded.

Currently, one of the flushers and one of the taps of the drinking fountains are malfunctioning. Although the supplier has been notified, according to the headmaster Augusto José Nhaca, it did not address the issue. Apart from these issues, the school has no problems related to the construction works already completed. The management of the toilets, stressed the headmaster, is done by the school employees and in shifts following the beginning and the end of the lessons in the three (3) shifts in question.

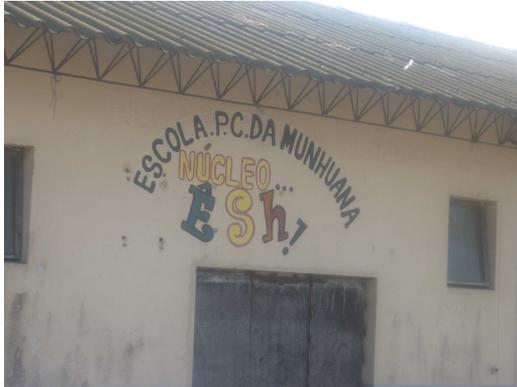
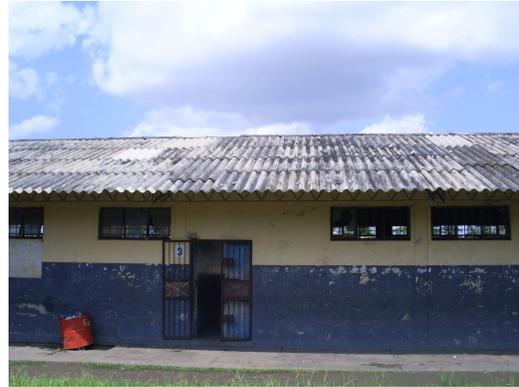
Pictures 5 and 6 EPC Munhuana before and after the replacement of the roofing

At the Munhuana Complete Primary School the rehabilitation focused on the gymnasium and the ceiling. In the ceiling of the gymnasium there was a replacement of the lusalite tiles for zinc sheets, whereas in the ceiling there was a replacement of the damaged lusalite tiles and cleaning, as shown in pictures 5 and 6.

According to Madalena Ndimande, Deputy Pedagogic Director, the gymnasium is currently in very poor conditions and the zinc sheet risk falling, which endangers the health of both students and teachers. Furthermore, there are classrooms without ceiling, the false ceiling is damaged and the Windows are broken.

Before the rehabilitation, the roof and toilets of the Munhuana EPC were in very bad conditions. The rainwater would often drip from the roof and the students sat on the floor. Due to the poor

drainage capacity of the soil, even with low intensity rain, the courtyard would be flooded and sometimes the water got inside the classrooms.

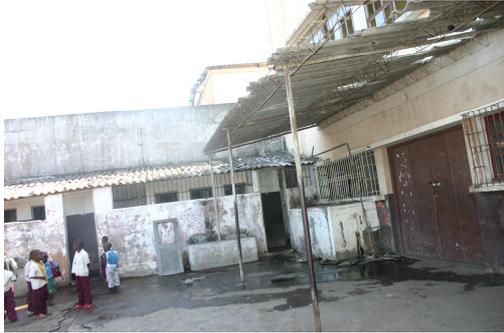
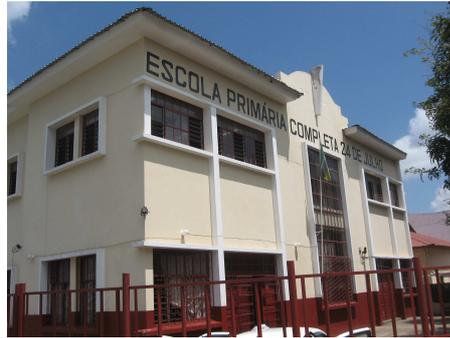
Pictures 7 and 8 EPC 24 de Julho before and after the rehabilitation

At the 24 de Julho Complete Primary School, before the rehabilitation, apart from the rainwater and sun rays, the walls also needed new painting. The roof covering the classrooms made an intense noise in rainy days, and the noise from the outside (cars, people) would come through the walls and be heard in the classrooms. The toilets were out of order, the blackboards and the doors were also degraded. This school received a general refurbishment, including the toilets for students, with a total cost of 2.722.019.56 Meticaís. Apart from these works, this school received 250 student desks and 10 desks with chairs for teachers.

The other interventions in the toilets also brought significant changes with regards to the previous situation. This contrast is better observed when we compare the pictures prior to the rehabilitation to those after.

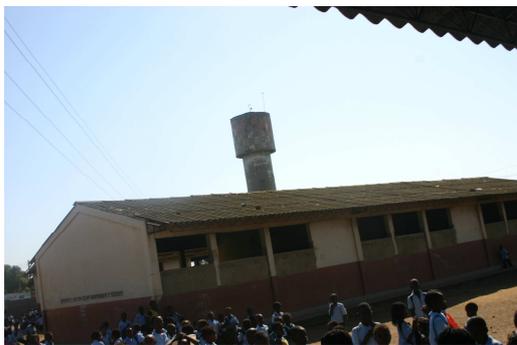
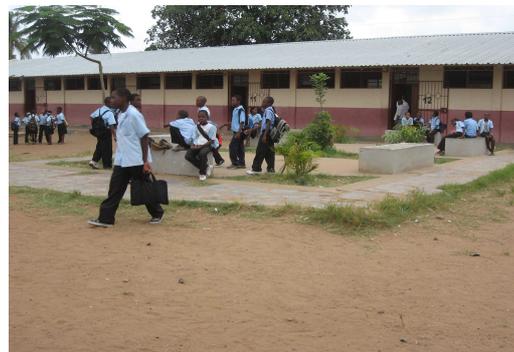
Pictures 9 and 10 EPC Unidade 13 before the rehabilitation

The Unidade 13 Complete Primary School had a situation pretty much similar to that of the previous school. It actually had problems with the roof (infiltration of rainwater and noise), painting, the toilets, which although in use they were not in good conditions, lack of glass on the windows, and blackboards.

The Unidade 13 Complete Primary School also had rehabilitation works that substantially changed its image. It was a general refurbishment, of which the most evident signs are the roof and toilets. The work carried out also includes the rehabilitation of drinking fountains.

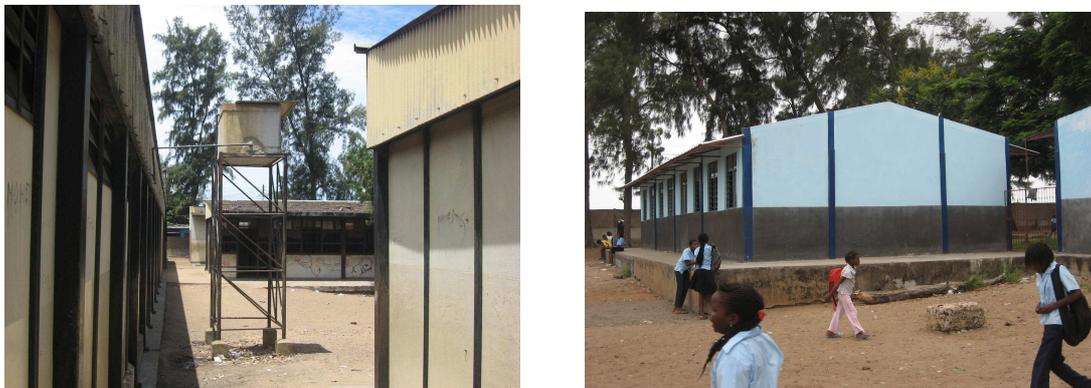
Pictures 11 and 12 EPC Unidade 18 before and after the rehabilitation

The Unidade 18 Complete Primary School faced a similar situation, thus, it benefited from a general rehabilitation including the toilets for students and teachers, water piping and the fencing wall. It needed, in fact, toilets, roof rehabilitation, new painting, walls and floor. This means that most of the schools were in need of an almost complete rehabilitation.

At the Unidade 18 EPC the toilets are in a good condition although the student's toilet is partially open due to frequent problems with the water pump.

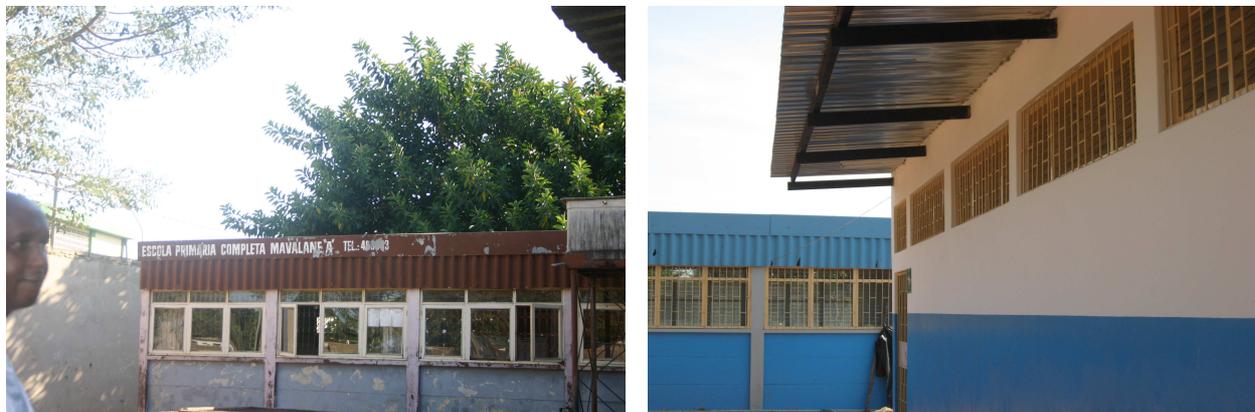
Pictures 13 and 14 EPC Mavalane “A” before and after the rehabilitation

The school has 12 classrooms and one gymnasium that sheltered to streams before the rehabilitation. It had problems related to the roof that allowed rainwater in, lack of student desks and toilets in very bad conditions. The drinking fountains no longer worked and the classrooms did not have glass on the windows. The school was, thus, in terrible conditions.

With the beginning of the project for rehabilitation and equipment of this school, the situation changed significantly. In the roof, some zinc sheets that were still in good conditions were re-used. The toilets improved significantly and are still in good conditions, the same happening with

the student desks that were introduced.¹⁰ Bars were also installed due to possible acts of vandalism.

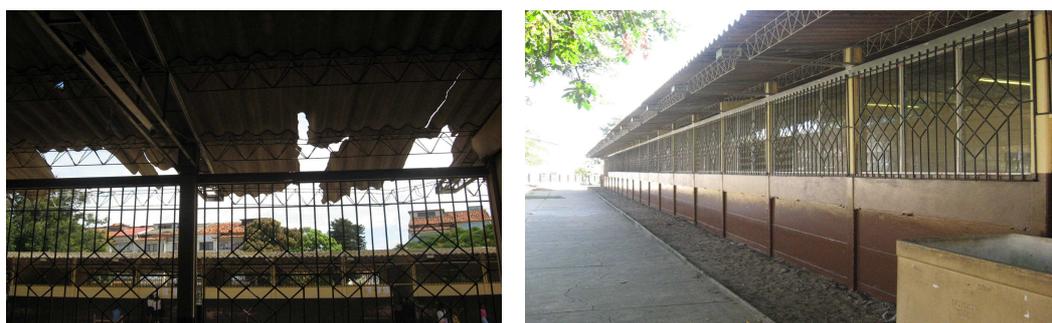
Pictures 15 and 16 EPC 25 de Setembro before and after the rehabilitation

Before the rehabilitation, the 25 de Setembro EPC had problems with the roof, classrooms, including the administrative section. The teachers’ toilets were also in poor conditions, the same with the furniture and drinking fountains.

With the ICEIDA-DECCM project, the school received the rehabilitation of the classrooms, including the ceiling, the administrative sections, storage, installation of drinking fountains and furniture for teachers and students.

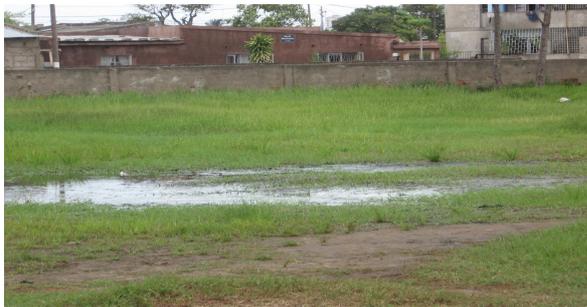
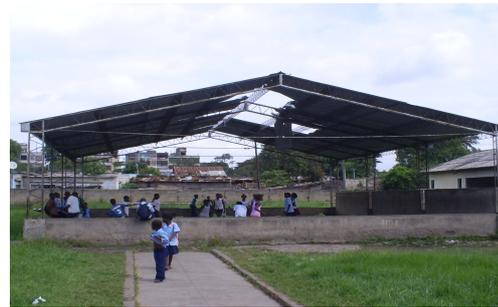
Through their own means they solved part of the problems; the toilets are in good conditions and the water runs normally; but with the rain the courtyard gets totally flooded.

Picture 17 and 18 flooded courtyard at the EPC Minkadjuine and Gymnasium at the EPC Munhuana after the replacement of the roofing

At the gymnasium of the EPC Munhuana new zinc sheets were placed replacing the lusalite. However, no so long after the roofing conditions deteriorated, thus, jeopardizing the life of students and teachers. The courtyard also gets flooded with the rainwater and the sanitation conditions even worse.²⁸ The same can be said with regards to the EPC 24 de Julho (the best rehabilitation was the toilet), but the difference is that the roof was rehabilitated stopping the infiltration of rainwater.

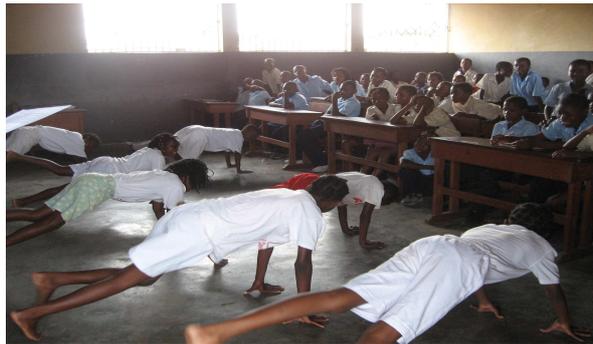
However, the observations we could find that despite the initial effort, there is still a lot to do specially in the Unidade 13 and Minkadjuine EPCs. The first needs a gymnasium because the students have their physical education in the courtyard, and electricity to illuminate all the blocks. The second school need a gymnasium because the students have their physical education inside the classrooms.

Picture 19. Physical education session in one classroom at the EPC Minkadjuine

The above situation has major implications in the academic performance. The solution for the constant flooding of the soil was using the classrooms for both physical education activities and intervals. This is a situation where the students come into the classroom and only leave when they are going home, except when they go to the toilet. Contrarily, the condition of the toilets in this school is quite good.
